Huber Airpark HOA Meeting Minutes

Huber Airpark Runway Committee

Findings and Recommendations

***Tom J. Freeman's Huber Runway Report**
Key Points – March 25, 2015

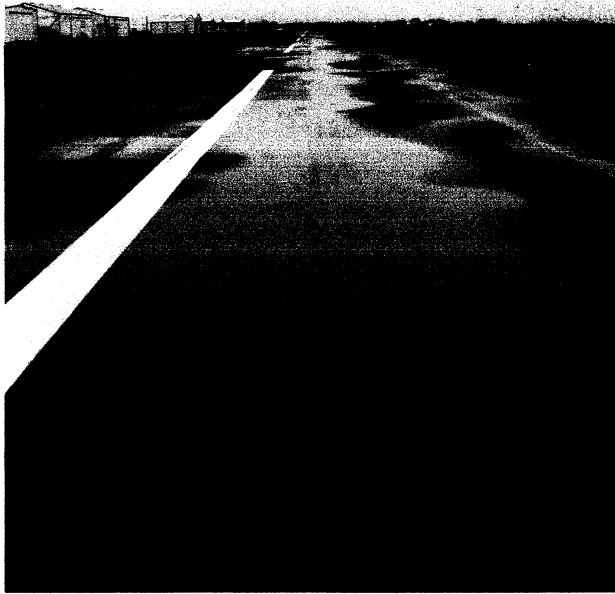
The runway, as it sits, has various problems, which include: low spots (bird baths), cracks of various size, and edge deterioration due to weed and grass encroachment. The combination of the bird baths and cracks allow for rain water penetration, causing soft spots to develop under the asphalt. As a result, the low spots and the major cracks need to be filled as quickly as possible to prevent further damage and to prepare the runway for the overlay.

Bird Baths Looking North

1. Soft roll the runway to identify and repair the soft spots.
2. Fill and level the largest, if not all, of the bird baths.
3. Apply and roll 2" of Type C (structural) asphalt. This will greatly strengthen the existing runway and provide a sealed structural base for the finish overlay.
4. Apply, roll, and crown 1 ½" of Type D (finish) asphalt. This will give us the crown we need to remove rain water quickly, before it has time to penetrate any major cracks.
5. Lower and grade the land on the East side of the runway to provide for better (quicker) drainage into Walnut Branch.
6. Address the runway edge grass/weed encroachment.

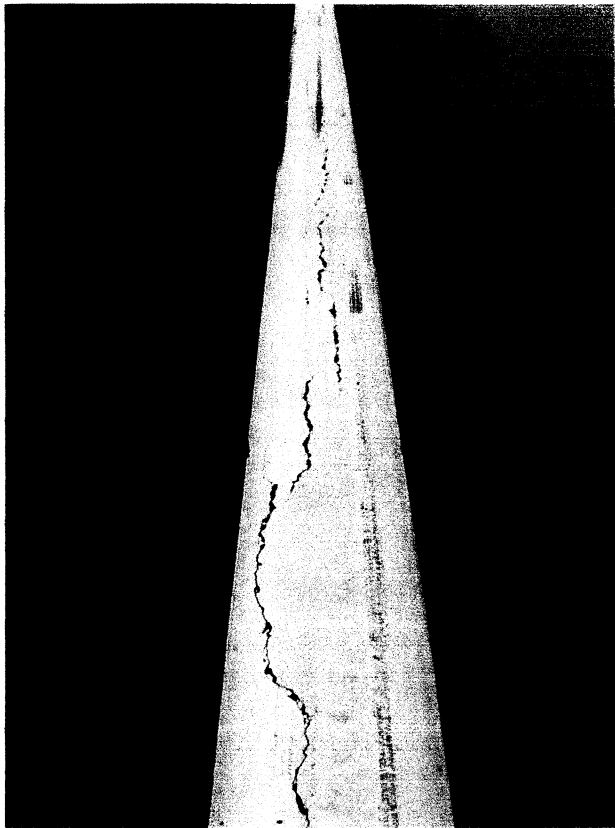
Typical Cracks

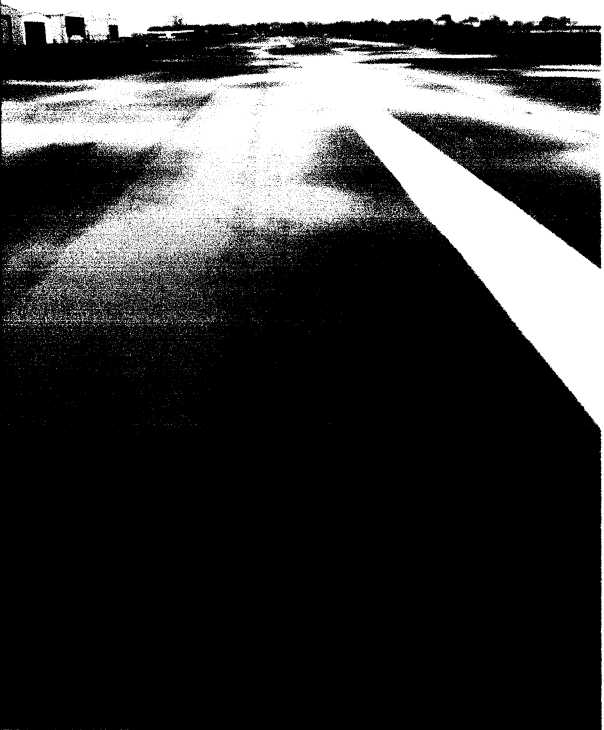
Typical Cracks
