Huber Airpark HOA Meeting Minutes

Huber Airpark Runway Committee

Findings and Recommendations

***Tom J. Freeman's Huber Runway Report**
Key Points – March 25, 2015

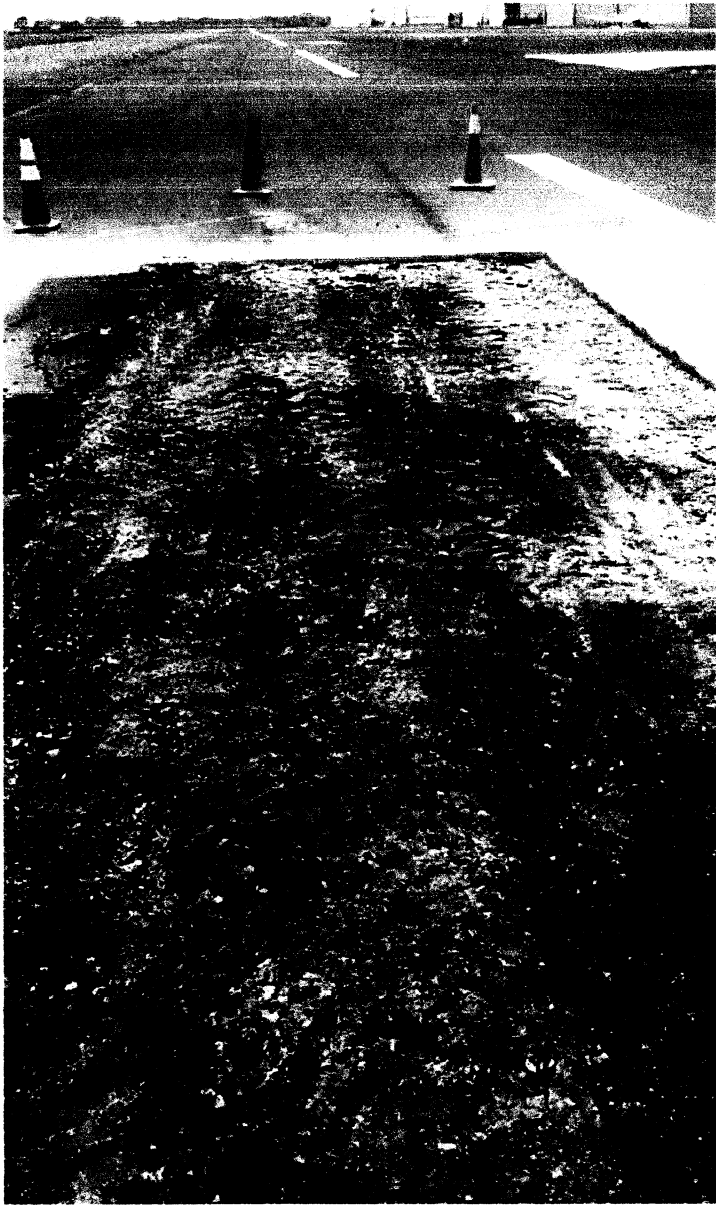
The runway, as it sits, has various problems, which include: low spots (bird baths), cracks of various size, and edge deterioration due to weed and grass encroachment. The combination of the bird baths and cracks allow for rain water penetration, causing soft spots to develop under the asphalt. As a result, the low spots and the major cracks need to be filled as quickly as possible to prevent further damage and to prepare the runway for the overlay.

Bird Baths Looking North

1. Soft roll the runway to identify and repair the soft spots.
2. Fill and level the largest, if not all, of the bird baths.
3. Apply and roll 2" of Type C (structural) asphalt. This will greatly strengthen the existing runway and provide a sealed structural base for the finish overlay.
4. Apply, roll, and crown 1 ½" of Type D (finish) asphalt. This will give us the crown we need to remove rain water quickly, before it has time to penetrate any major cracks.
5. Lower and grade the land on the East side of the runway to provide for better (quicker) drainage into Walnut Branch.
6. Address the runway edge grass/weed encroachment.
